# **Golfing atop a landslide** A signature hole is born at Trump National Golf Course

### By Rich Sack

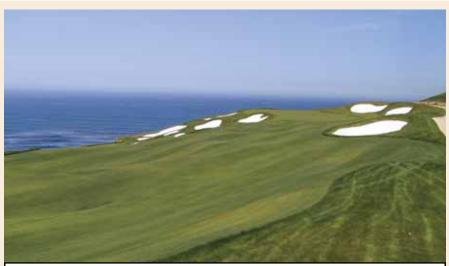
**Photo 1**. A landslide took out most of the 18th hole. The rebuild created a signature hole and a signature geotechnical design.

result was the movement of a large "translational block," which occupies the central portion of the slide mass. The slide saw downward movement of almost 10 ft. and horizontal (seaward) translation of about 50 ft. At the base of the slide was an almost horizontal thin layer of bentonite, only 0.12–3 in. thick, that when exposed to water becomes extremely slippery (low friction). The slide mass had a maximum length of 1700 ft., a width over 400 ft. and depth of about 70 ft. The slide took with it most of the 18th hole (fairway and green), bluff edge, pedestrian trails, bikepath, and a portion of a major Los Angeles County Sanitation District sewer line. Many believe that fluid from a leak in this sewer line may have flowed along and saturated the thin layer of betonite, triggering the massive slide.

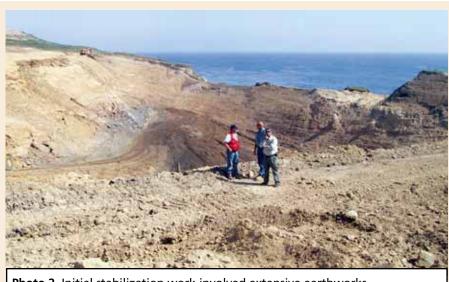
Photo 2. Initial stabilization work involved extensive earthworks.

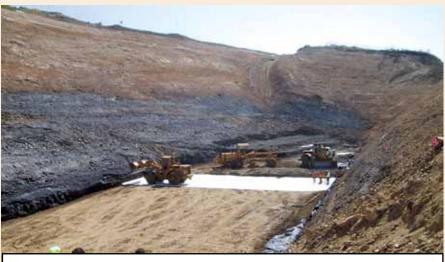
**Photo 3**. Numerous geotextiles and soil baskets provided vital internal support for the refilled hole.

The actual wall design was performed by Bill Lu at Converse Consultants. The design required interface friction testing for both secondary and primary reinforcement layers for use in global and surficial stability design calculations. Extremely high strength fabrics (over 40,000 lbs/ft. tensile strength) combined with high soil interaction coefficients were essential to the design. Layers of geosynthetic reinforcement were to be placed at approximately 5 ft. vertical intervals with embedment lengths as much as 95 ft. in length (using the higher strength fabrics allowed for larger vertical spacing—resulting in lower installation costs). Mirafi® Geolon® PET600, PET300, PET200 and HS4200 were used as the primary reinforcement to create a massive fabric-wrapped MSE wall buttress (100 ft.+ high). The face of the wall was designed with 18 in. high welded wire forms. The forms were designed to be manufactured with a batter of 4.6° (almost vertical) to match the final design batter of the wall. Mirafi® Filterweave® 404 was designed as secondary reinforcement that would line the interior of the welded forms to contain soil at the face. The face of this massive MSE wall was to abut another reinforced triangular backfill. This second reinforced fill mass abutted existing slide material/native soils of the seaward portion of the landslide, which was left in place to maintain the natural environment, hide the face of the wall, and protect the wall structures from the Pacific Ocean's rage. This composite of soil and high-strength fabric serves as a giant stable soil block that will stop any future movement and protect he rest of the rest of the golf course from falling into the ocean.

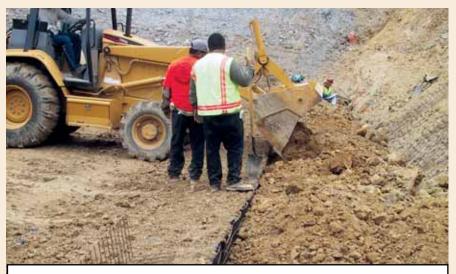
Photo 4. Constructing the geosynthetic-reinforced MSE wall buttress.

The first step in repairing the slide area was to stabilize the main slide block with 116 shear pins. Each steel pin was 20 ft. long, 3 ft. wide, and filled with high-density concrete. Shear pins were installed at 25 ft. intervals. Once the shear pins were installed the construction of the MSE wall began by first excavating the slide area (over 1.5 million cubic yards of soil) in sections (6 sections total) to a depth below the failure plane (approximately 100–150 ft.). The 9th and 12th fairways were used for stockpiling the soil from the first section, so that no impact would be made on the sensitive habitat adjacent to the site. Construction of the MSE wall began with placement of the first row of welded wire forms at the bottom of the excavation. Once the first course of forms were placed, the Filterweave 404 was placed up the back of the steel forms, with a 5 ft. long flap of reinforcement draped over the face. Geolon high strength fabric was next placed up to the face of the basket. (The fabric was pre-cut and brought down into the excavation for placement.) On-site fill materials were compacted in place over the reinforcement lengths, and the flap was wrapped back over the top of the soil. The construction process was repeated for each lift (every 18 in.), until the wall reached its full required design height. Total cost: \$61 million.
